S/25982
21 June 1993

Letter dated 10 June 1993 from the Director-General of
the International Atomic Energy Agency addressed to the
Secretary-General

REPORT ON THE NINETEENTH IAEA ON-SITE INSPECTION IN IRAQ
UNDER SECURITY COUNCIL RESOLUTION 687 (1991)
30 April - 7 May 1993

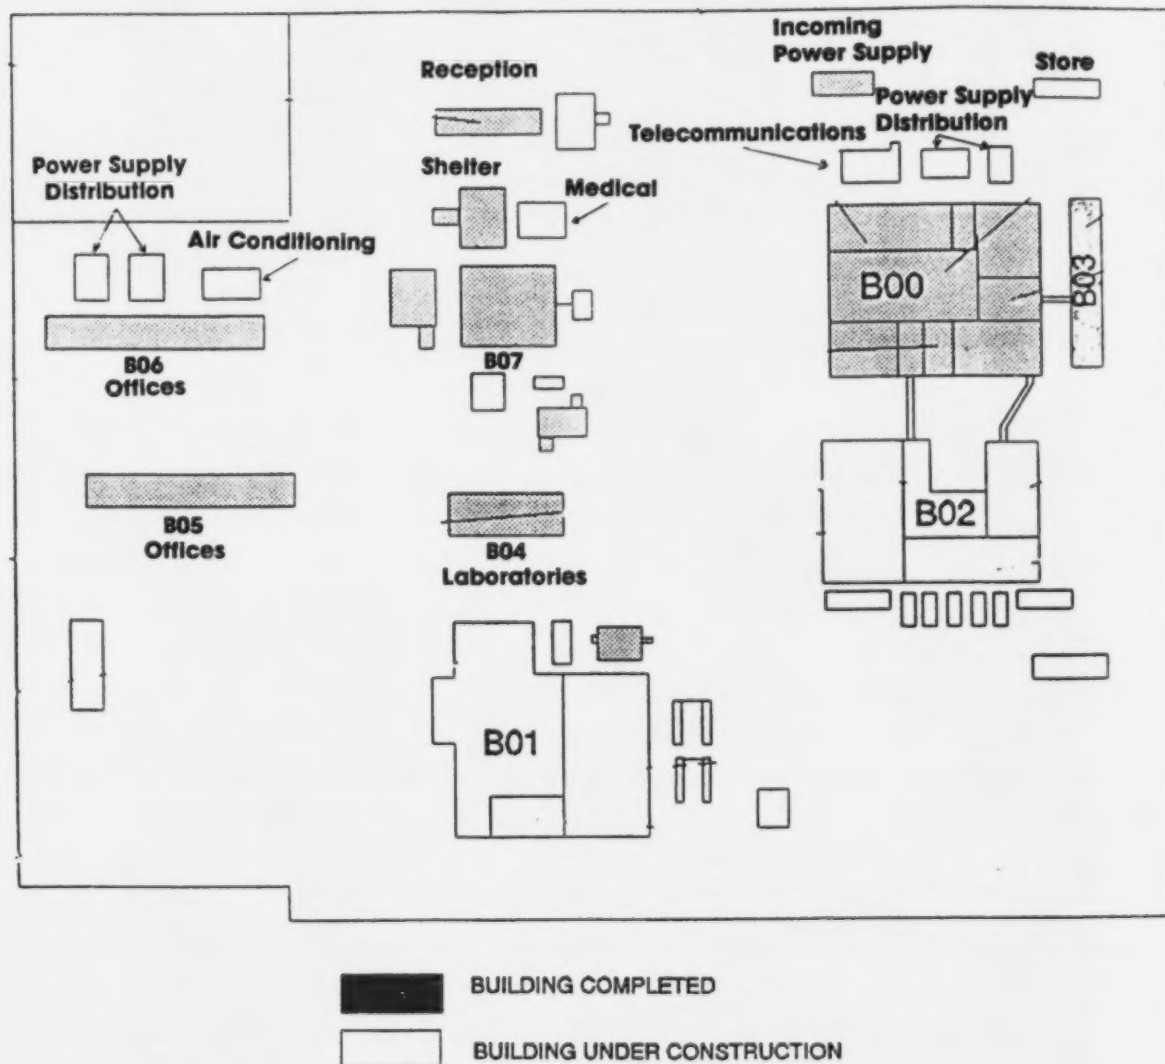
FIGURE 2. THE AL FURAT PROJECT SITE

17. Al Furat project site (see Figure 2) - This site was being developed by the Iraqi side as a centrifuge manufacturing and test facility when work stopped at the time of the Gulf War. According to an Iraqi statement, the site had originally been a training centre with dormitories, cafeteria and training hall to which three new buildings (B01, B02 and B03) were being added when the conversion to a centrifuge manufacturing and testing facility was decided. Building B03 - a raw materials store - was complete and buildings B01 and B02 were in the early stages of construction when work stopped. All other buildings go back to the training centre application, although building B00 (the main training hall) was being modified.

When the IAEA-19 team arrived for the inspection, they found a large workforce busy reconfiguring and refurbishing the pre-existing buildings. The Iraqi counterpart indicated that the facility now belongs to the Military Industrial Committee (MIC) and that they were preparing it for some use, but he did not know what it was. The team proceeded to walk through every building on the site. Buildings B01, B02 and B03 (i.e. those buildings added for the centrifuge programme), with the exception of scavenging for building materials, are untouched. All other buildings are being modified and refurbished. By all appearances, the site is being converted into an office complex. Even the large halls in B00 are being partitioned into halls and office size cubicles. The same is true of the former barracks indicated as B05 and B06. The site has the possibility for a large power supply. Thirteen transformer bays were counted. Only one had a transformer installed (1000 kVA), but two additional 1000 kVA and one 630 kVA transformer are available for installation. Probably the potential power supply relates to the centrifuge manufacturing application, but those buildings were being refurbished along with the rest. The utilities, ventilation, etc., being installed in buildings B00, B05 and B06 are modest. The Iraqi counterpart was requested to provide the team with a written explanation of the planned use of the facility before the team's departure. A reply was received two days later, at the time the team was leaving Baghdad. This matter which needs further clarification (Attachm.1), will be pursued during the next inspection.
